LAKE ARROWHEAD DAM
FRANKLIN COUNTY, MISSOURI
MO 30572

PHASE 1 INSPECTION REPORT NATIONAL DAM SAFETY PROGRAM

Name of Dam: Lake Arrowhead Dam
State Located: Missouri
County Located: Franklin
Stream: Johnson Branch Meramec River
Date of Inspection: 24 August 1978

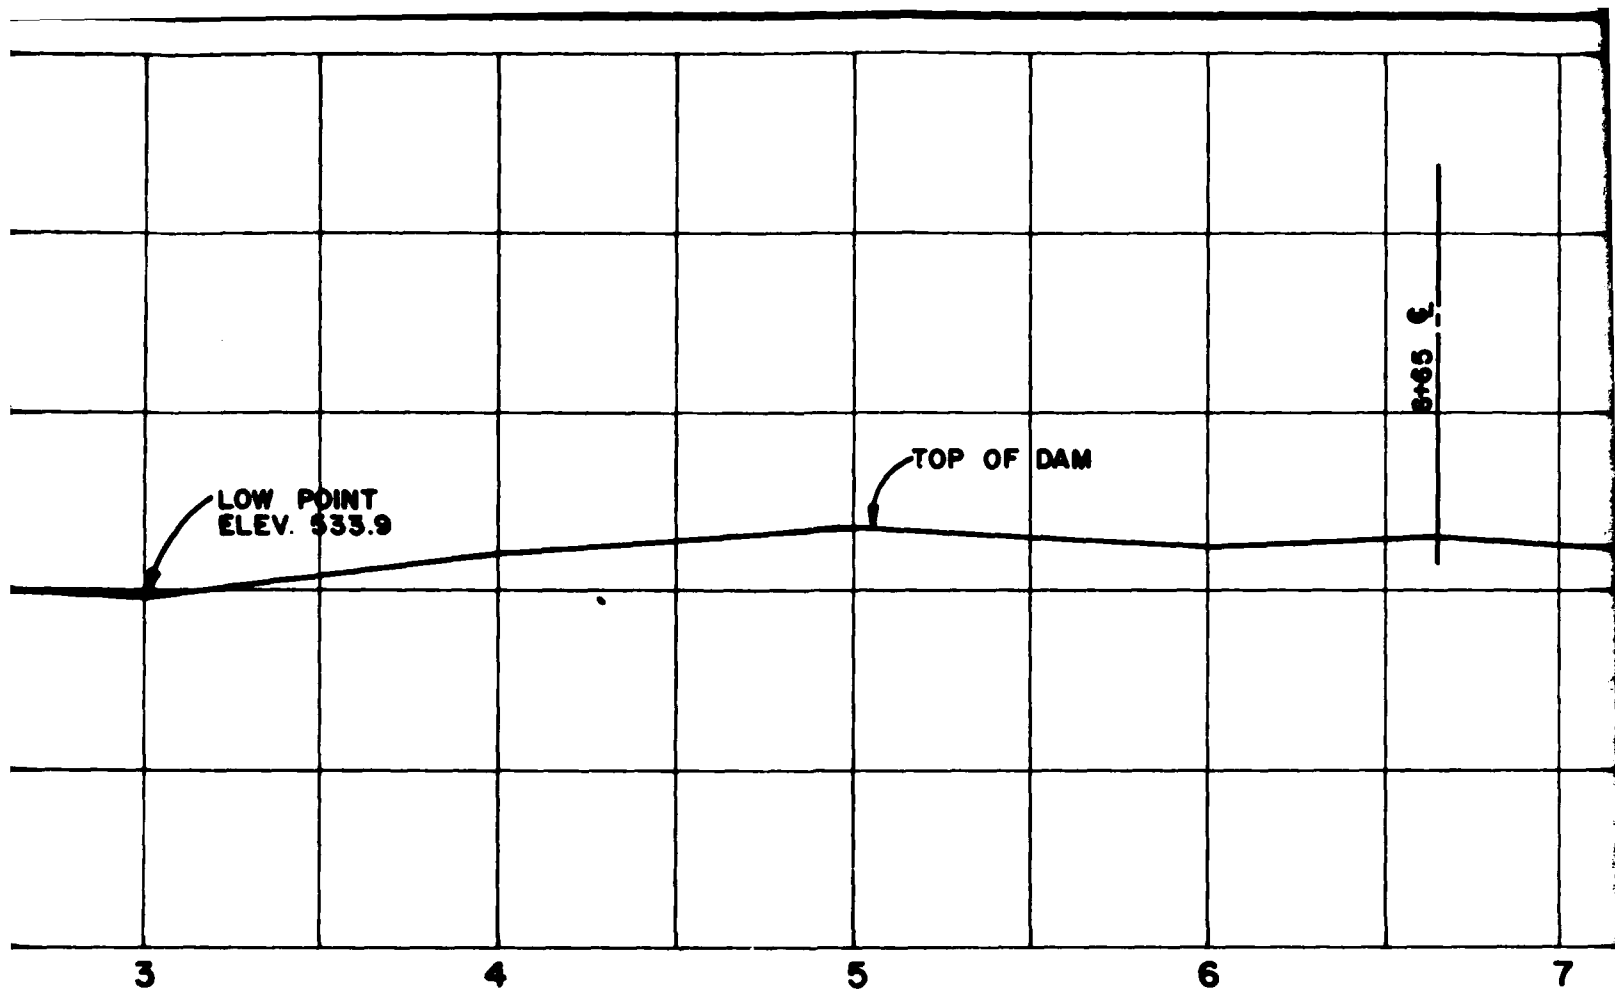
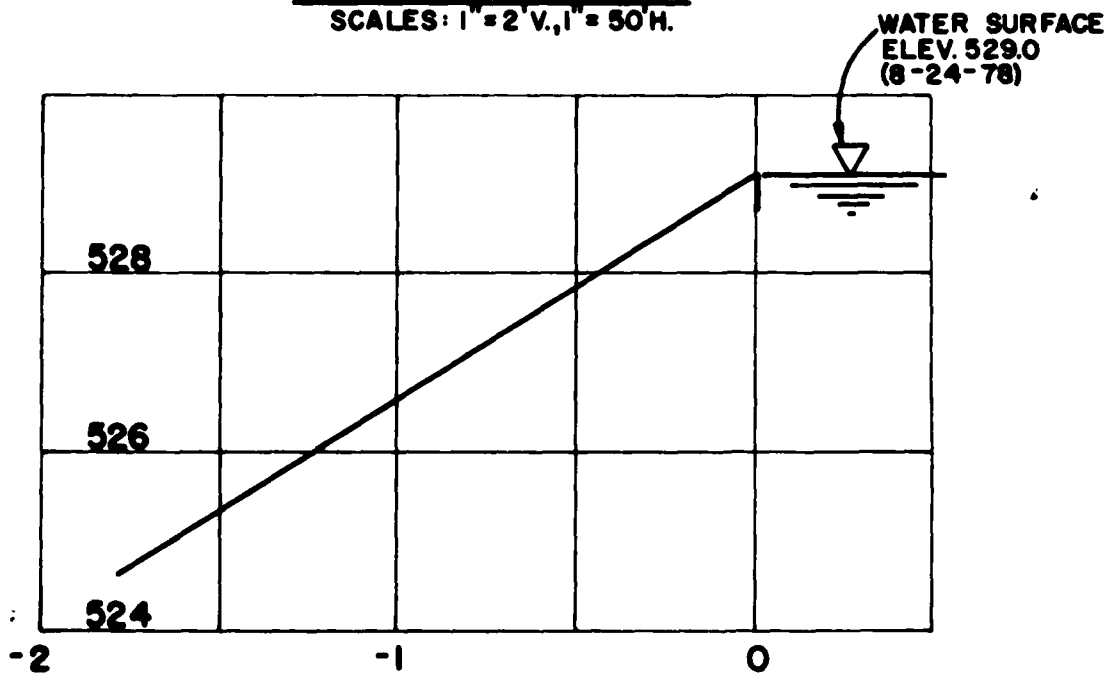
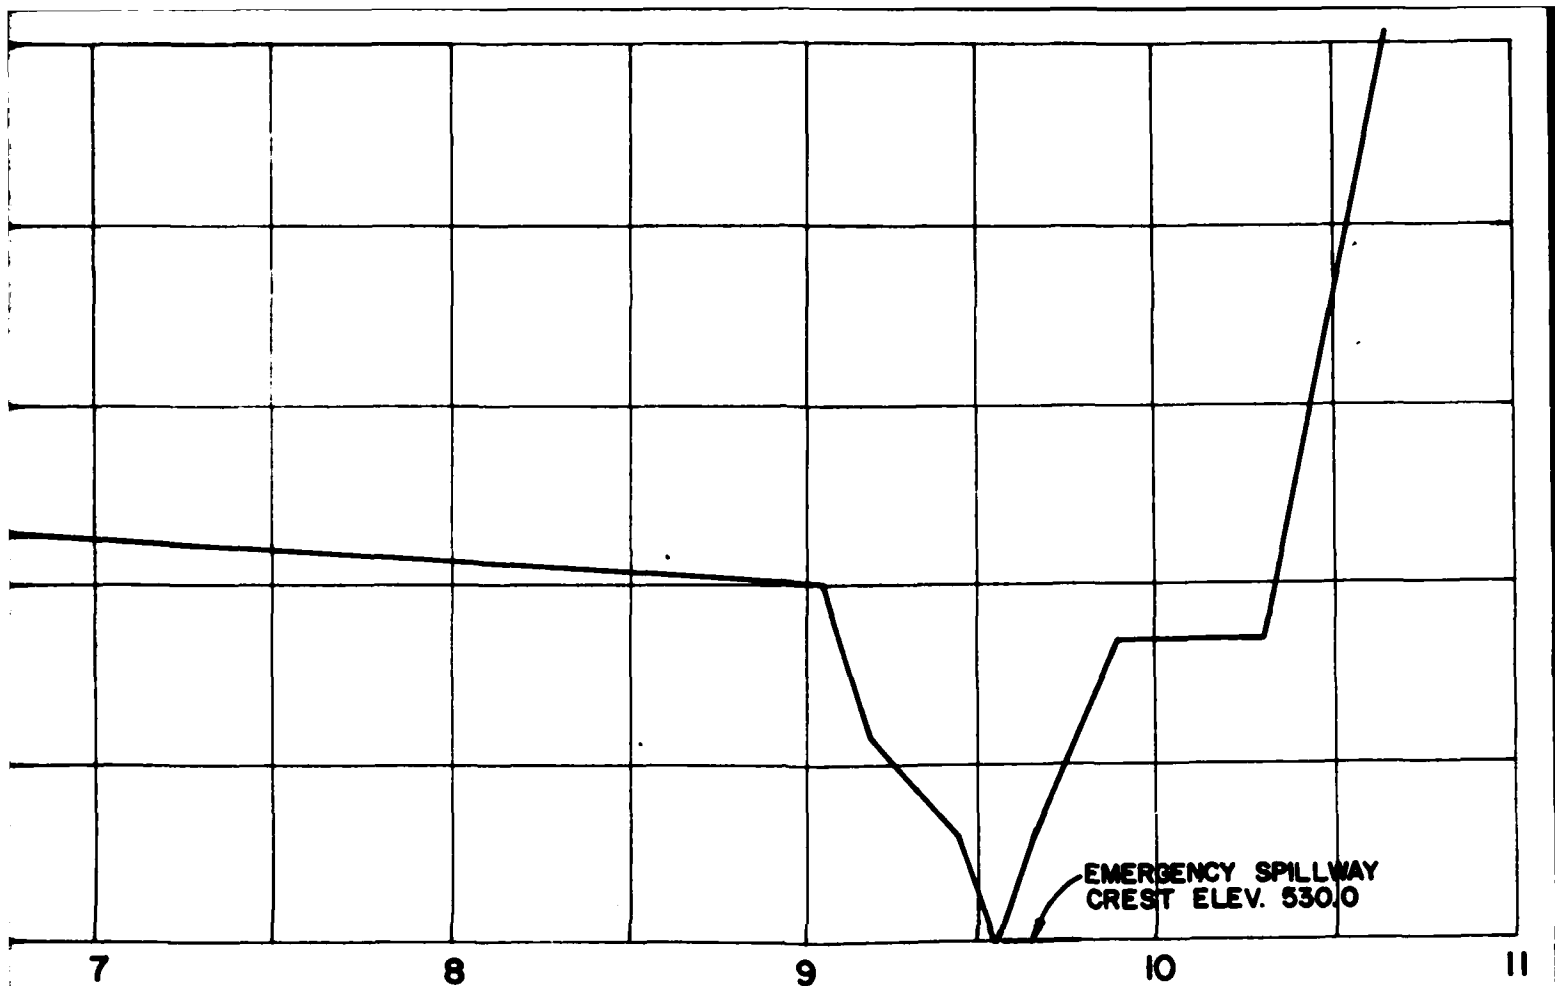
**LAKE ARROWHEAD
DAM & SPILLWAY PROFILES**

The top of the dam was found to be about 2 feet lower at a point near the center of the dam than in the area adjacent to the principal spillway. The low point of the dam is approximately 5 feet higher than the principal spillway crest and 4 feet higher than the emergency spillway crest. A profile of the top of the dam extending through the crests of the principal and emergency spillways and based on survey data obtained during the inspection is shown on Plate 3.

(1) Based upon criteria set forth in the recommended guidelines, alterations to this design of the dam should be made in order to pass lake outflow resulting from a storm of probable maximum flood magnitude. In any event, it is recommended that the low area located near the center of the dam be raised such that it no longer restricts spillway capacities.
